Property Condition Report

Case #: 105-106945
Address: 2136 Kellington Drive
City: McDonough
State/Zip: GA 30253
Inspection Date: 11/12/08
Inspection Type: Property Condition Report (PCR)
Prepared by: DEANCO Management Services, Inc.

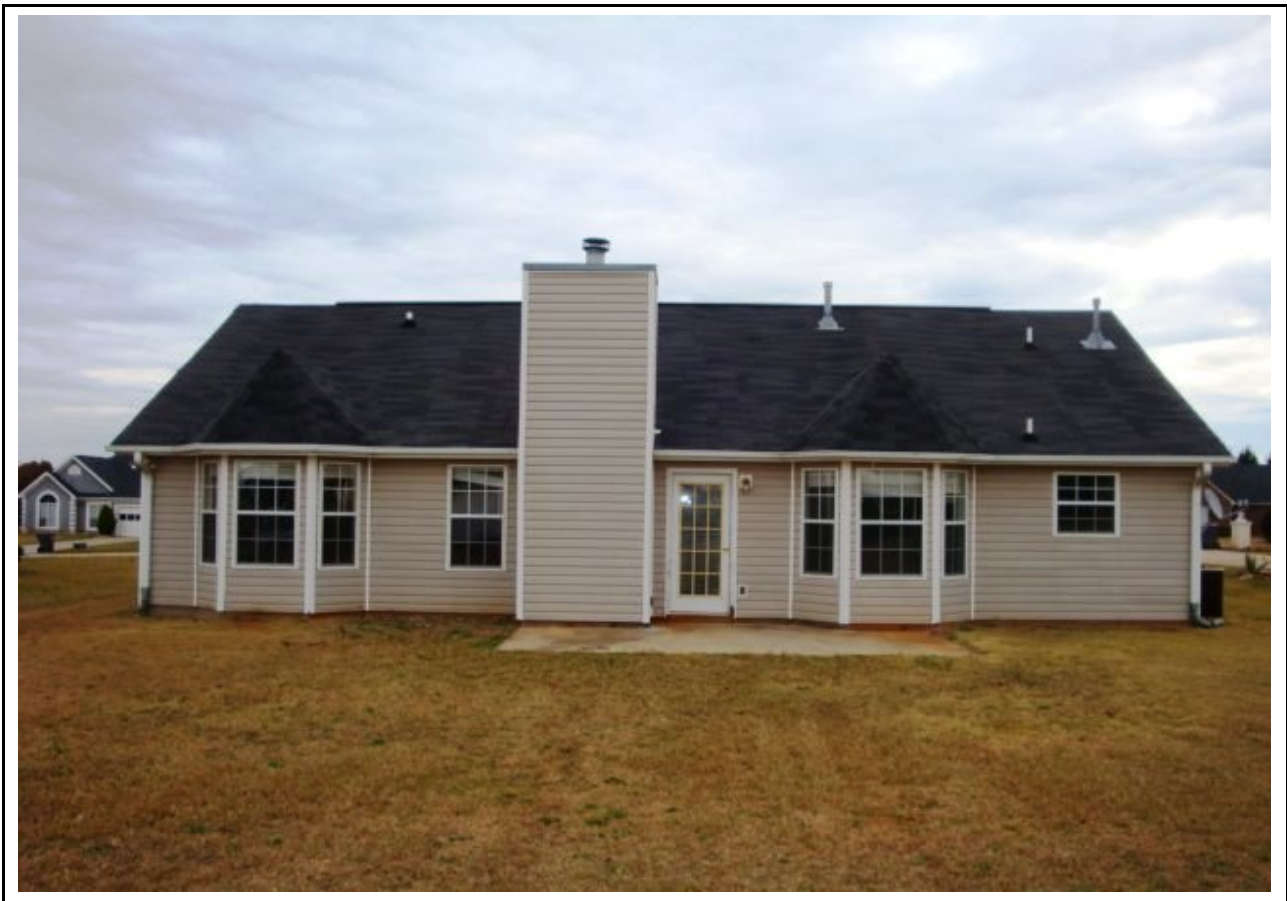
Photo-Rear View of Property

>Siding has numerous projectile damaged areas along the lower portions of the siding mainly at the rear.
